Slope Stability Problems Related to a Semi-Bridge Construction

SYNOPSIS: In the area of "AKTEA", a summer-housing estate 36 Km away from the city of Athens, a great landslide affected the stability of a semi-bridge, constructed in 1980 for the widening of the nearby national road. Preliminary studies carried out before the semi-bridge construction and after the observed damage of most of the houses in the uphill area, favoured the existence of a very superficial creep affecting however the one or two storey buildings of the summer-housing estate.

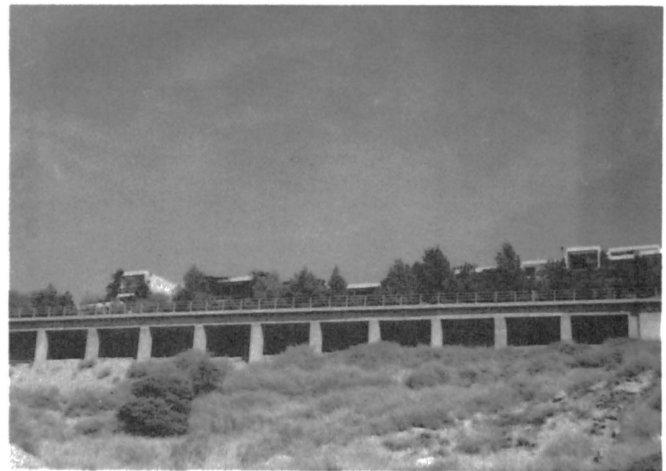
Fig. 4 View of the Semi-bridge and of "AKTEA" Summer-housing Estate

The semi-bridge which was constructed for the road widening had a total length of about 60 metres and 12 spans with the sections of the roadway slab freely supported (Figures 4 and 5). During the excavation for the foundation construction the slope beside the working space was nearly vertical and without any temporary covering or support.

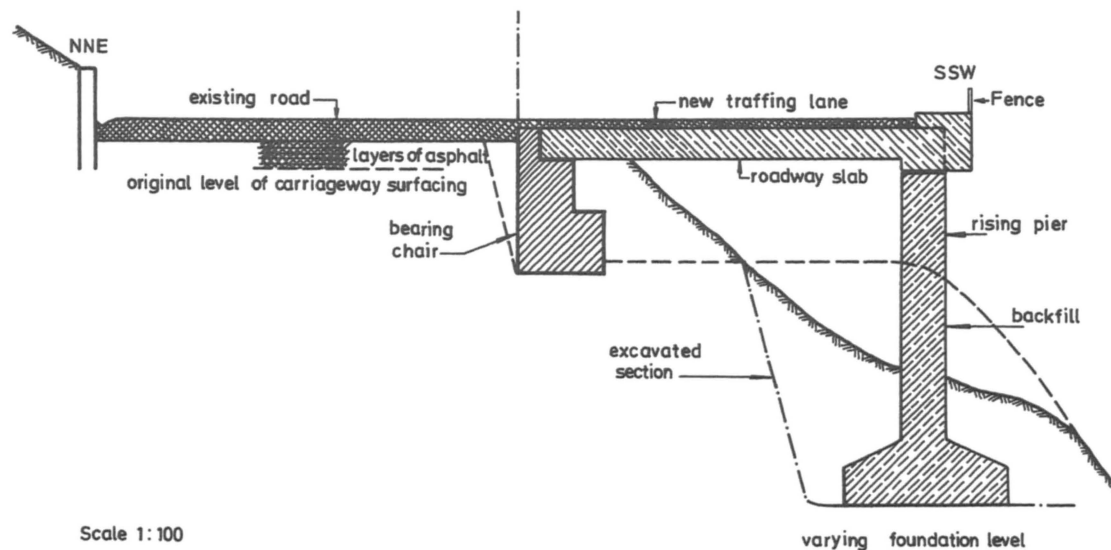
Fig. 5 Cross-section of the Semi-bridge and Details of Excavation and Backfilling

height of about seven metres. The construction of the piers was made in sections in order to avoid any risk of slope failure uphill from the semi-bridge. At that time the depth of the foundation level was considered to be satisfactory and in any case greater than the depth of the superficial creep.

A strip foundation (bearing chair) was constructed along the middle-line of the new road at an elevation of about three metres below the level of the existing road (Figure 5). The whole structure included also two wing-walls founded at about the same level as the piers.

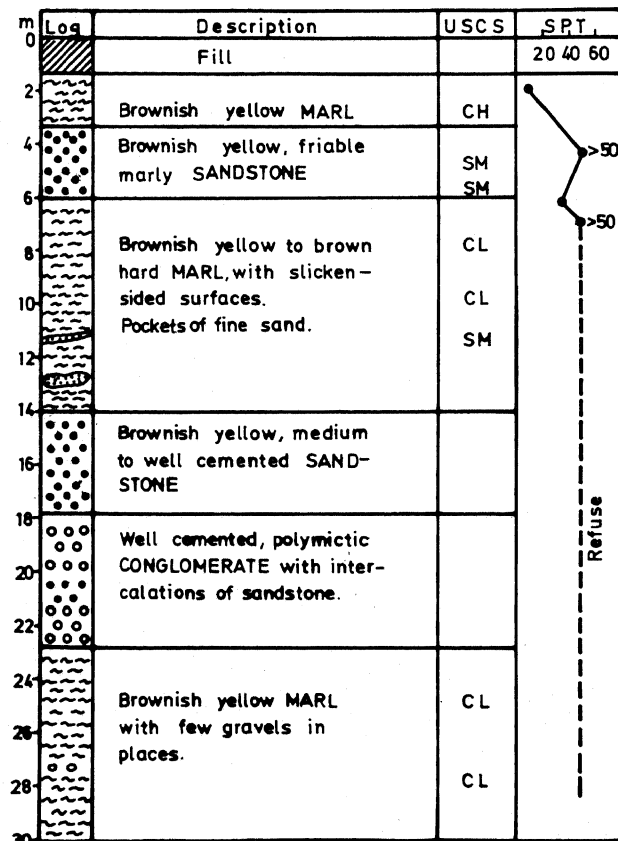
Fig. 8 Typical Soil Profile

In Figure 8 a typical soil profile is shown based on the logging of borehole B2. As is shown in this Figure the narrow area of the semi-bridge consists of alternating layers of conglomerate, sandstone and marl, whereas the upper 1 - 2 metres consist of fill material. The thickness of the well cemented, polymictic conglomerate is about 3 metres. The sandstone is friable and marly or well cemented and its thickness varies from 3 to 4 metres. The marl is hard in greater depths and presents some slickensided surfaces. The SPT

values for the surficial layers of marl range between 10 and 30 whereas in greater depths these marls present a refuse to SPT sampler penetration.
